QUINNIPIAC RIVER BASIN  
MERIDEN, CONNECTICUT  
**BRADLEY HUBBARD RESERVOIR DAM**  
**CT 00132**

PHASE I INSPECTION REPORT  
NATIONAL DAM INSPECTION PROGRAM

SEPTEMBER, 1980

4. TITLE (and Subtitle)  Bradley Hubbard Reservoir Dam  NATIONAL PROGRAM FOR INSPECTION OF NON-FEDERAL DAMS		5. TYPE OF REPORT & PERIOD COVERED  INSPECTION REPORT

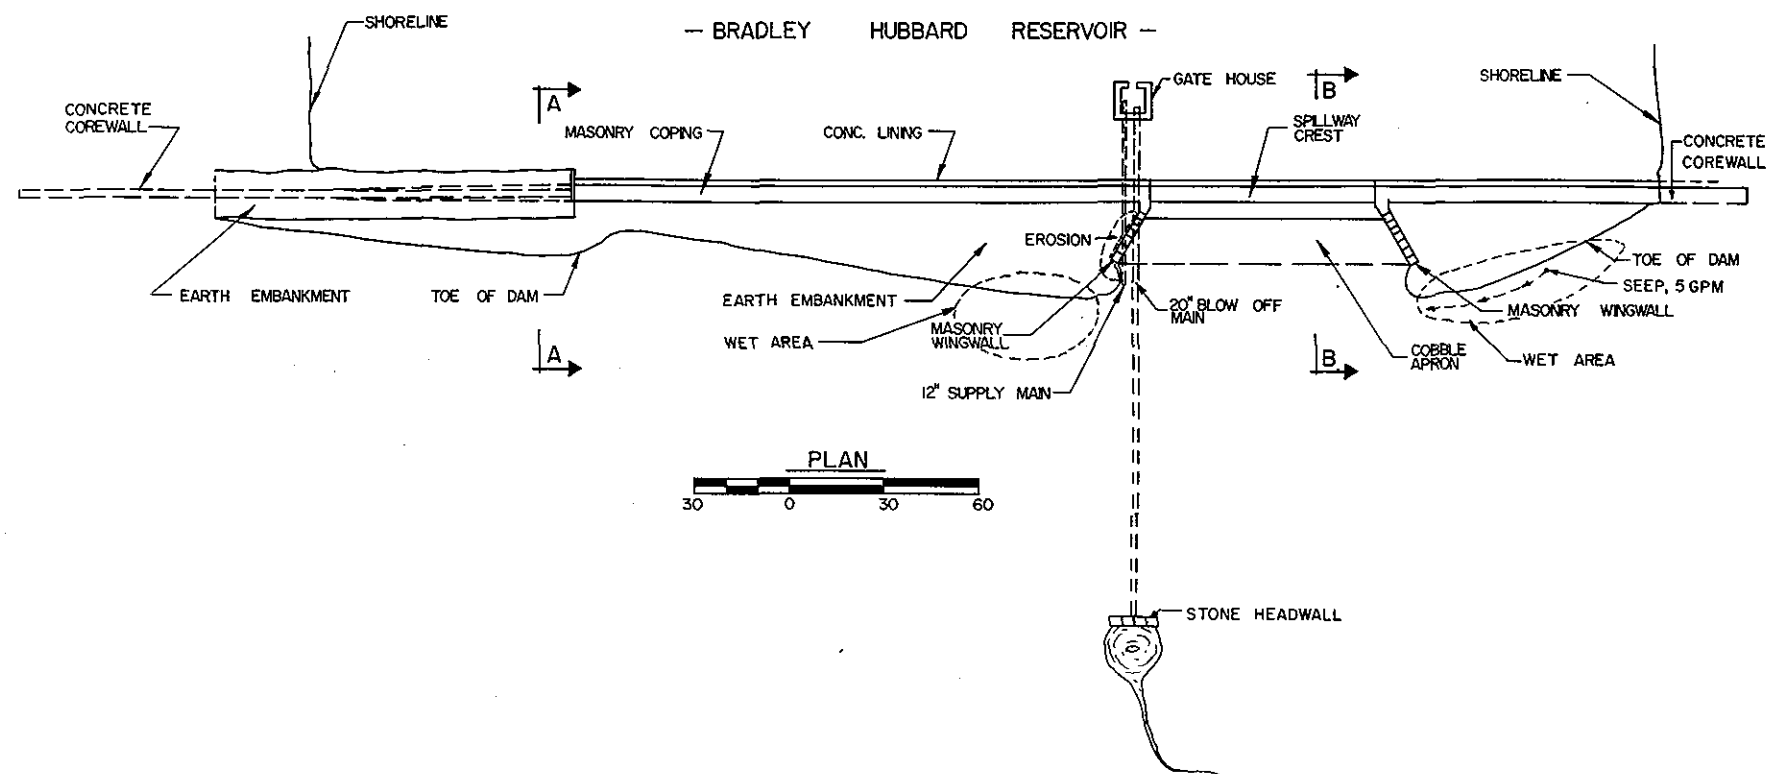
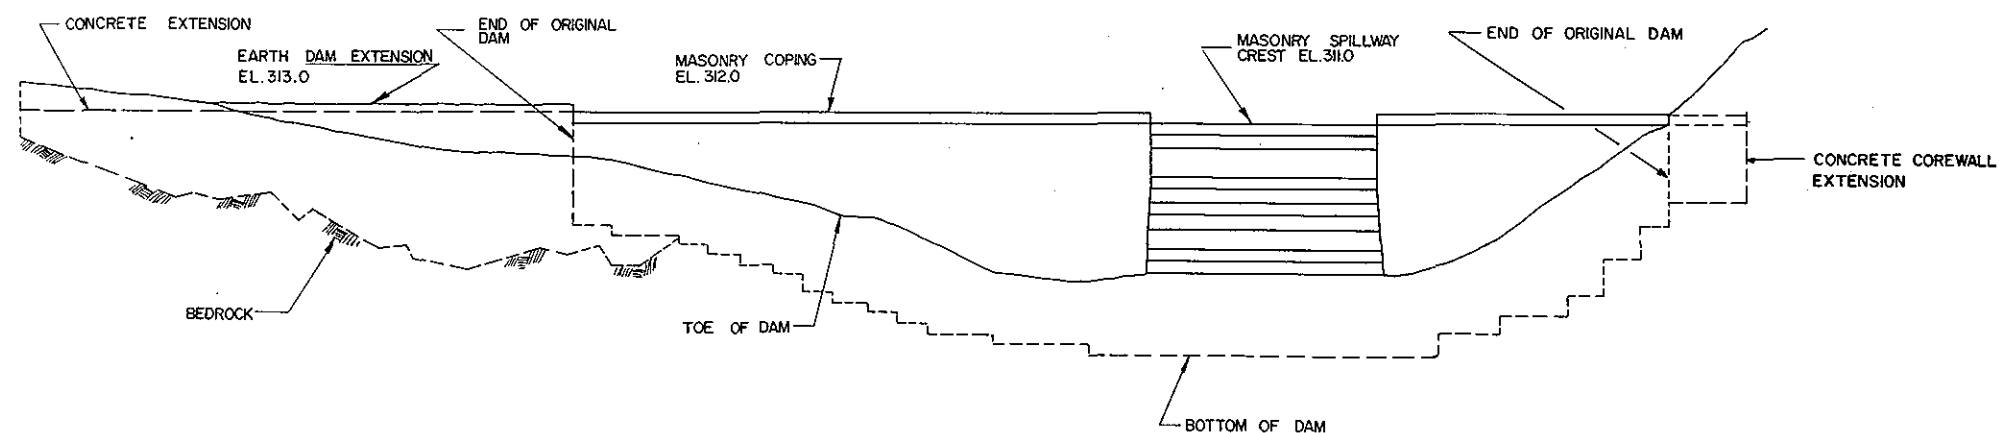
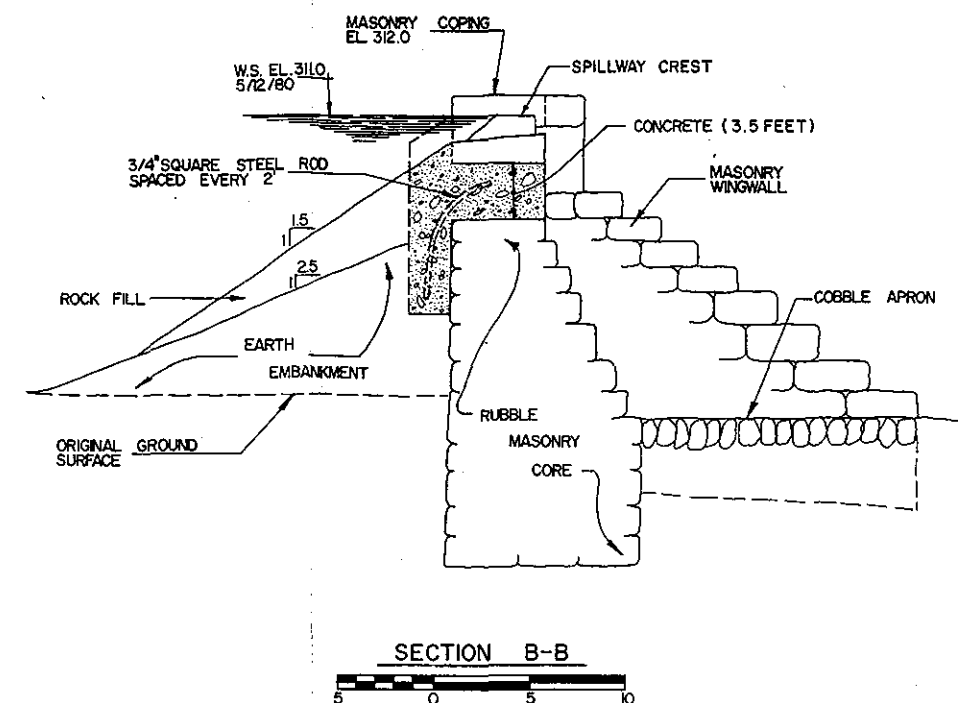
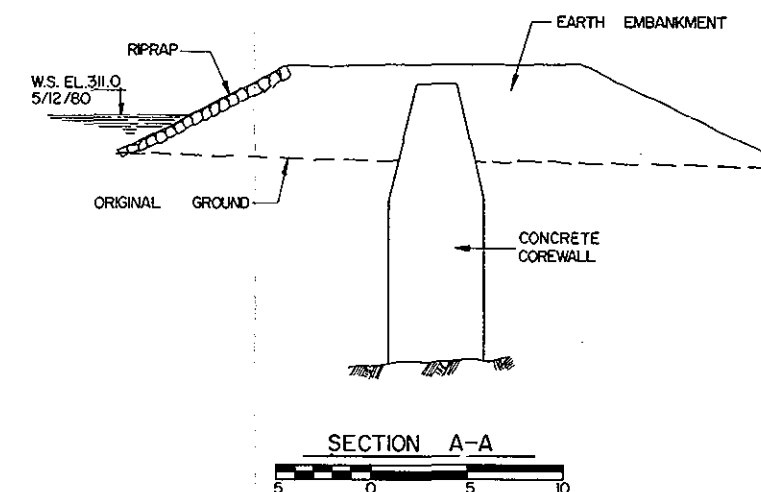
2. Vegetation growing through the masonry joints could lead to displacement and/or possible failure of the masonry.
3. Cracks between the newer concrete and the upstream face of the original masonry (See Sheet B-1), allow water to flow through the masonry section thus possibly leading to adverse seepage through the dam.

6. Sealing the cracks between the newer concrete section and the original masonry to prevent seepage through this area.

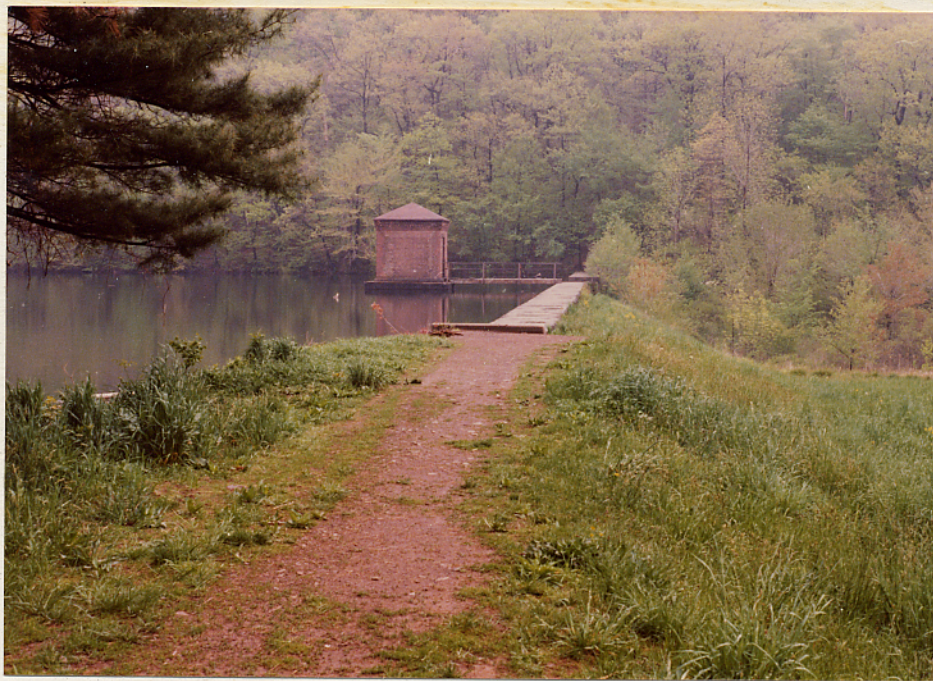
Top of Dam - The masonry coping contains cracks and deterioration within the mortar joints especially to the left side of the spillway. There is also vegetation growing from some of these cracks. The top of the earth embankment portion of the dam is bare and shows evidence of erosion (photos 1 and 2).

Photo 1 - Top of dam from right abutment. Note lack of protective cover on dike section in foreground (5/12/80)

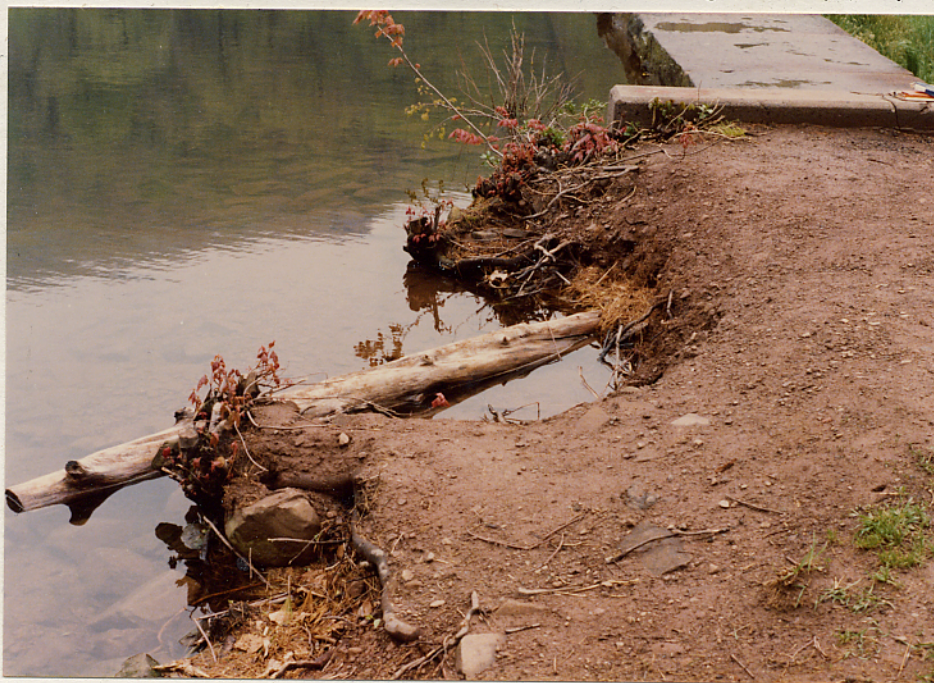
4. The lack of riprap or other suitable protective cover on the top and upstream slope of the embankment portion of the dam will permit further erosion which may possibly result in failure of the structure.

Photo 2 - Upstream embankment of dike section (5/12/80)

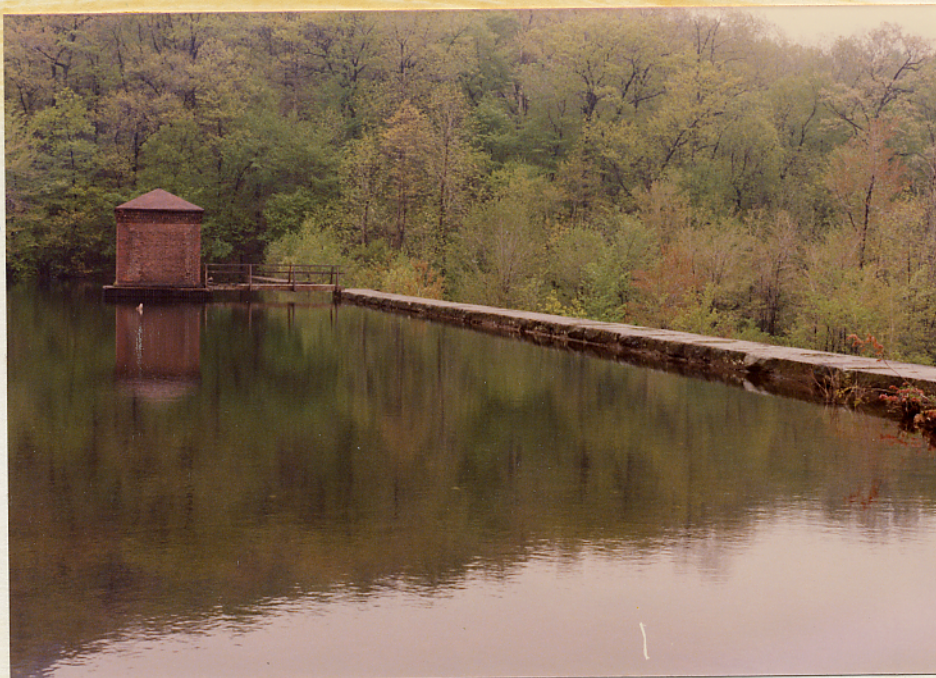
Photo 3 - Upstream side of masonry coping and gatehouse structure (5/12/80)

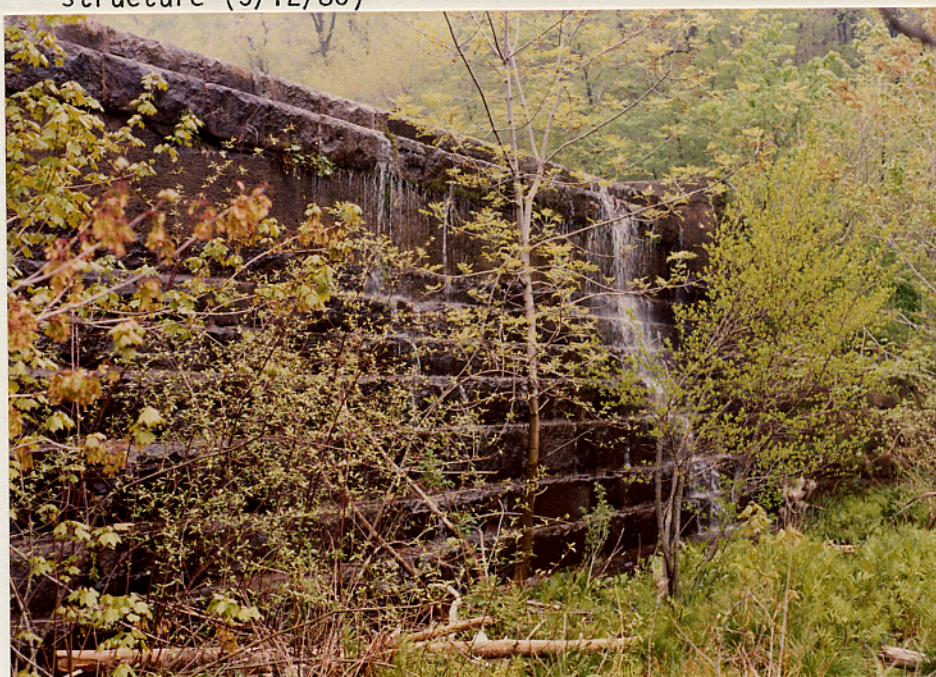
Spillway - The masonry spillway crest is in fair condition although there are some cracks and seepage through the masonry joints (photo 5). The approach channel is clear and free of obstructions. The training walls adjacent to the spillway crest show signs of slight erosion. Grasses and vines are growing from many of the joints in the masonry. Mortar is also missing from many of the joints (Photo 5). Seepage was observed from the joints of both training walls with flows averaging less than 1 gpm. The downstream face of the spillway is in fair condition although the masonry is a little eroded (Photo 4). The discharge channel is filled with debris and overgrown with trees and brush (Photos 4, 5 and 6).

Photo 4 - Stepped masonry spillway wall. Note vegetation in spillway channel and grass growing from masonry joints. (5/12/80)

8. The gate house door should be repaired.
9. The gate valve mechanisms should be repaired, cleaned, lubricated, and painted.
10. The discharge channel should be cleared of trees, brush and logs, and the cobble apron repaired to prevent erosion at the base of the spillway during high spillway discharge.

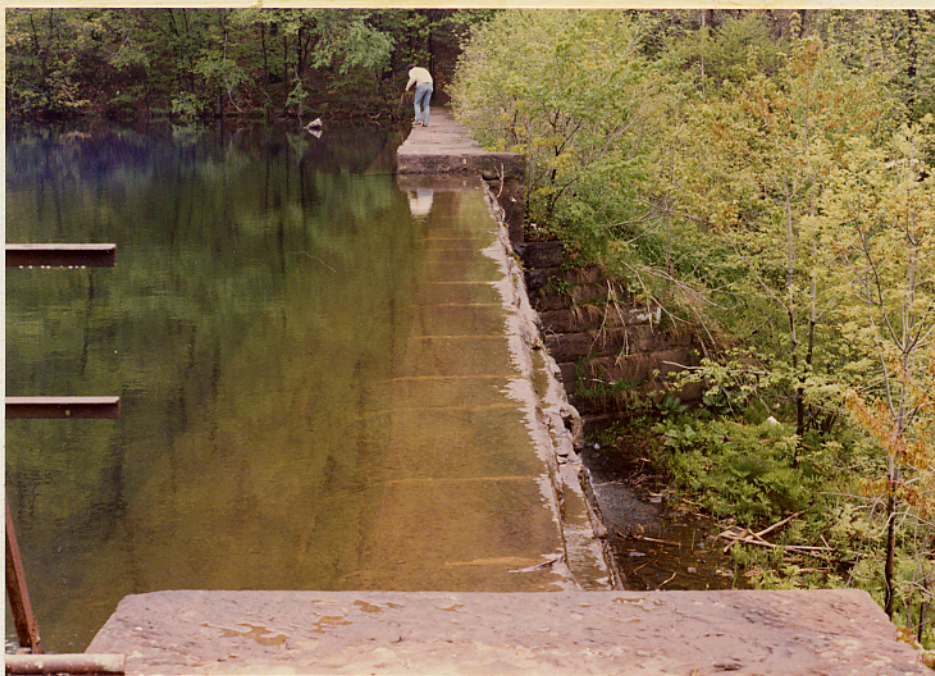
Photo 5 - Masonry spillway crest and left end of dam  
(5/12/80)

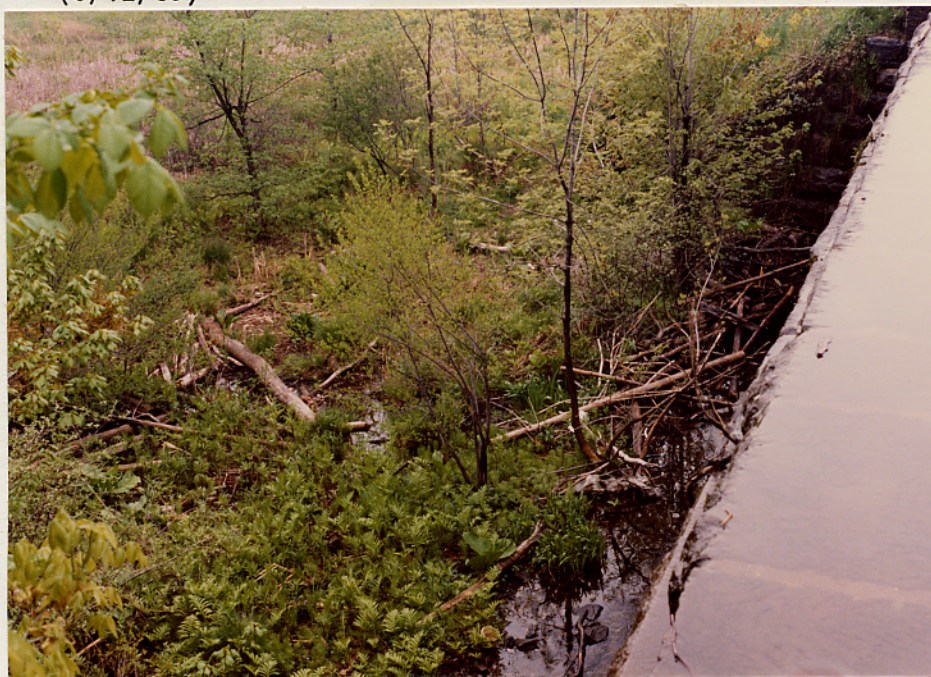
Photo 6 - View of spillway discharge channel from spillway  
crest (5/12/80)
